Horning Geosciences

November 7, 2016

RE: Geologic Hazard Reconnaissance of Potential New Fire Station Sites; nine sites in the greater Gearhart vicinity, Clatsop County, Oregon

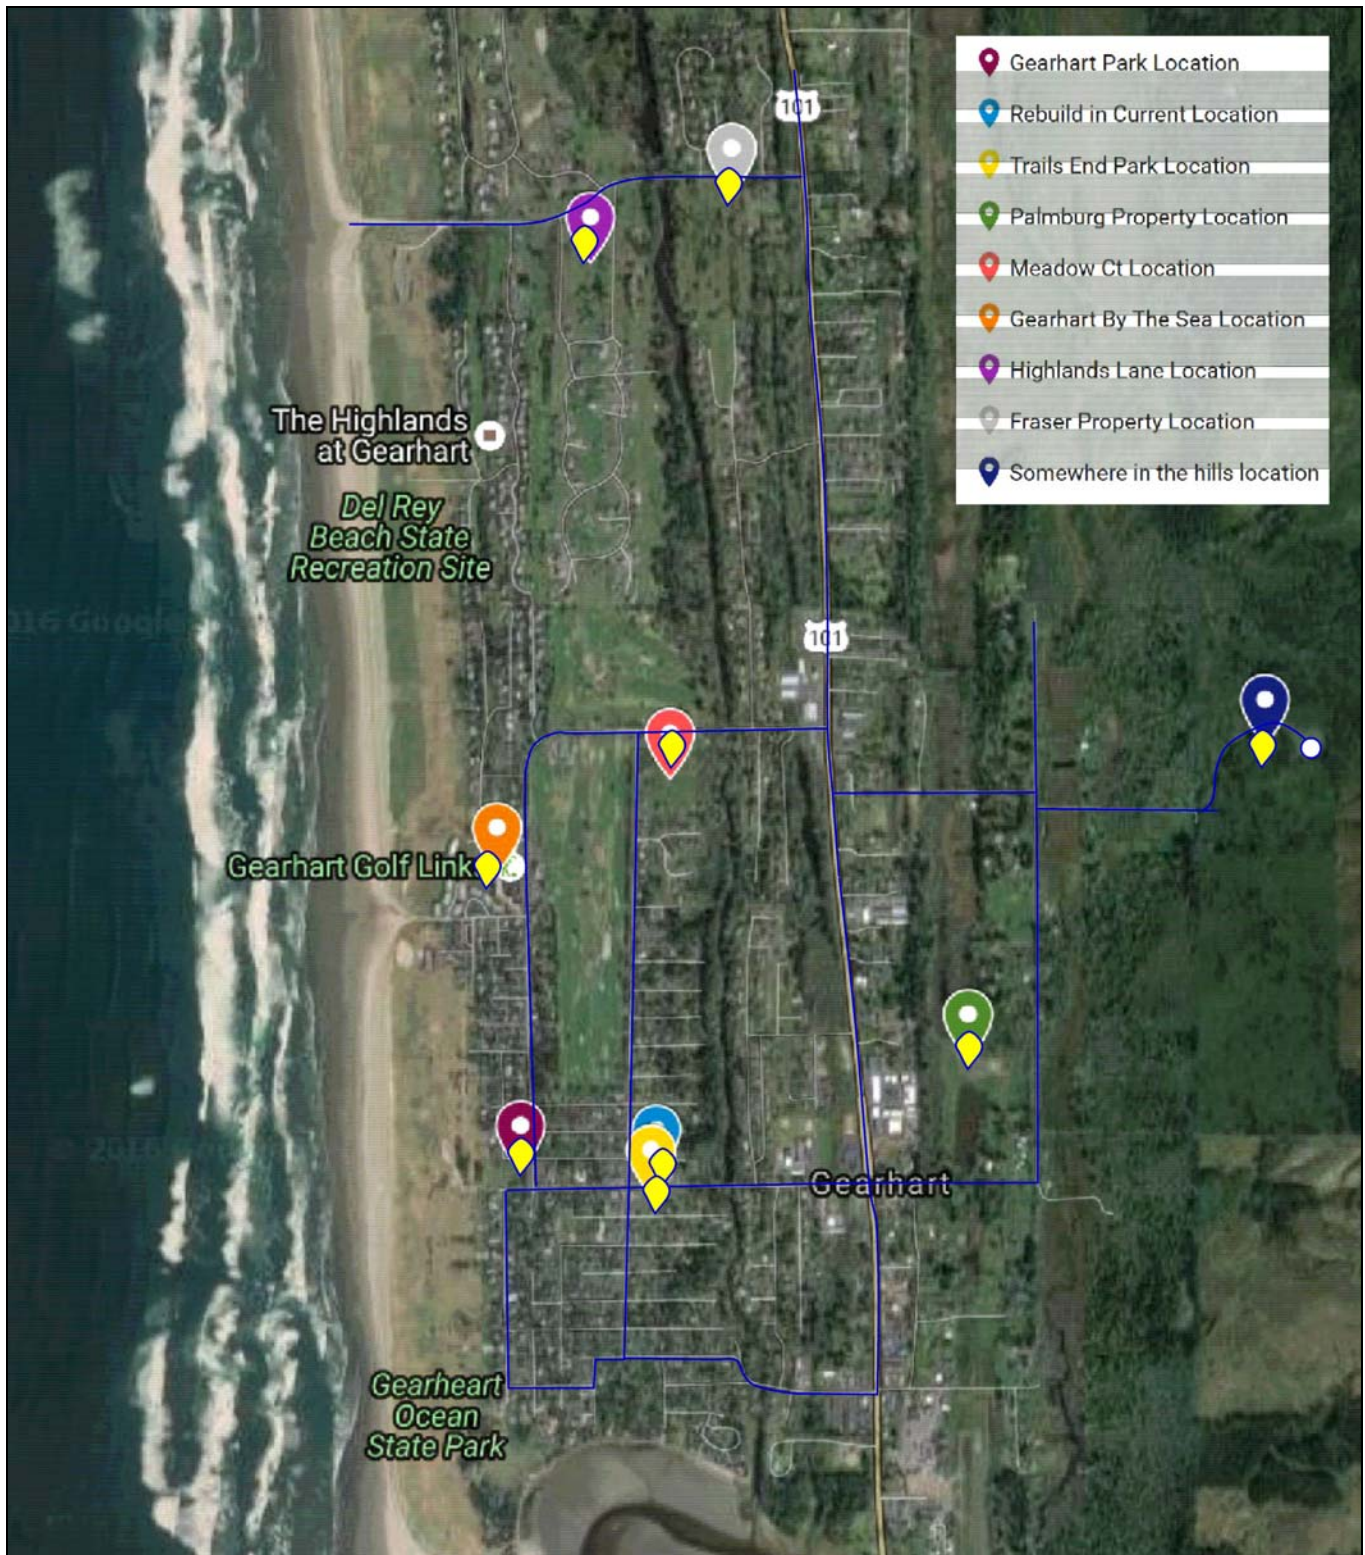
Figure 1: Aerial photo of the greater Gearhart area with nine possible sites for a new fire station. The smaller yellow symbols are reproduced and overlain on the following geologic maps of the area. Map provided by Dan Jesse, City Councilor.

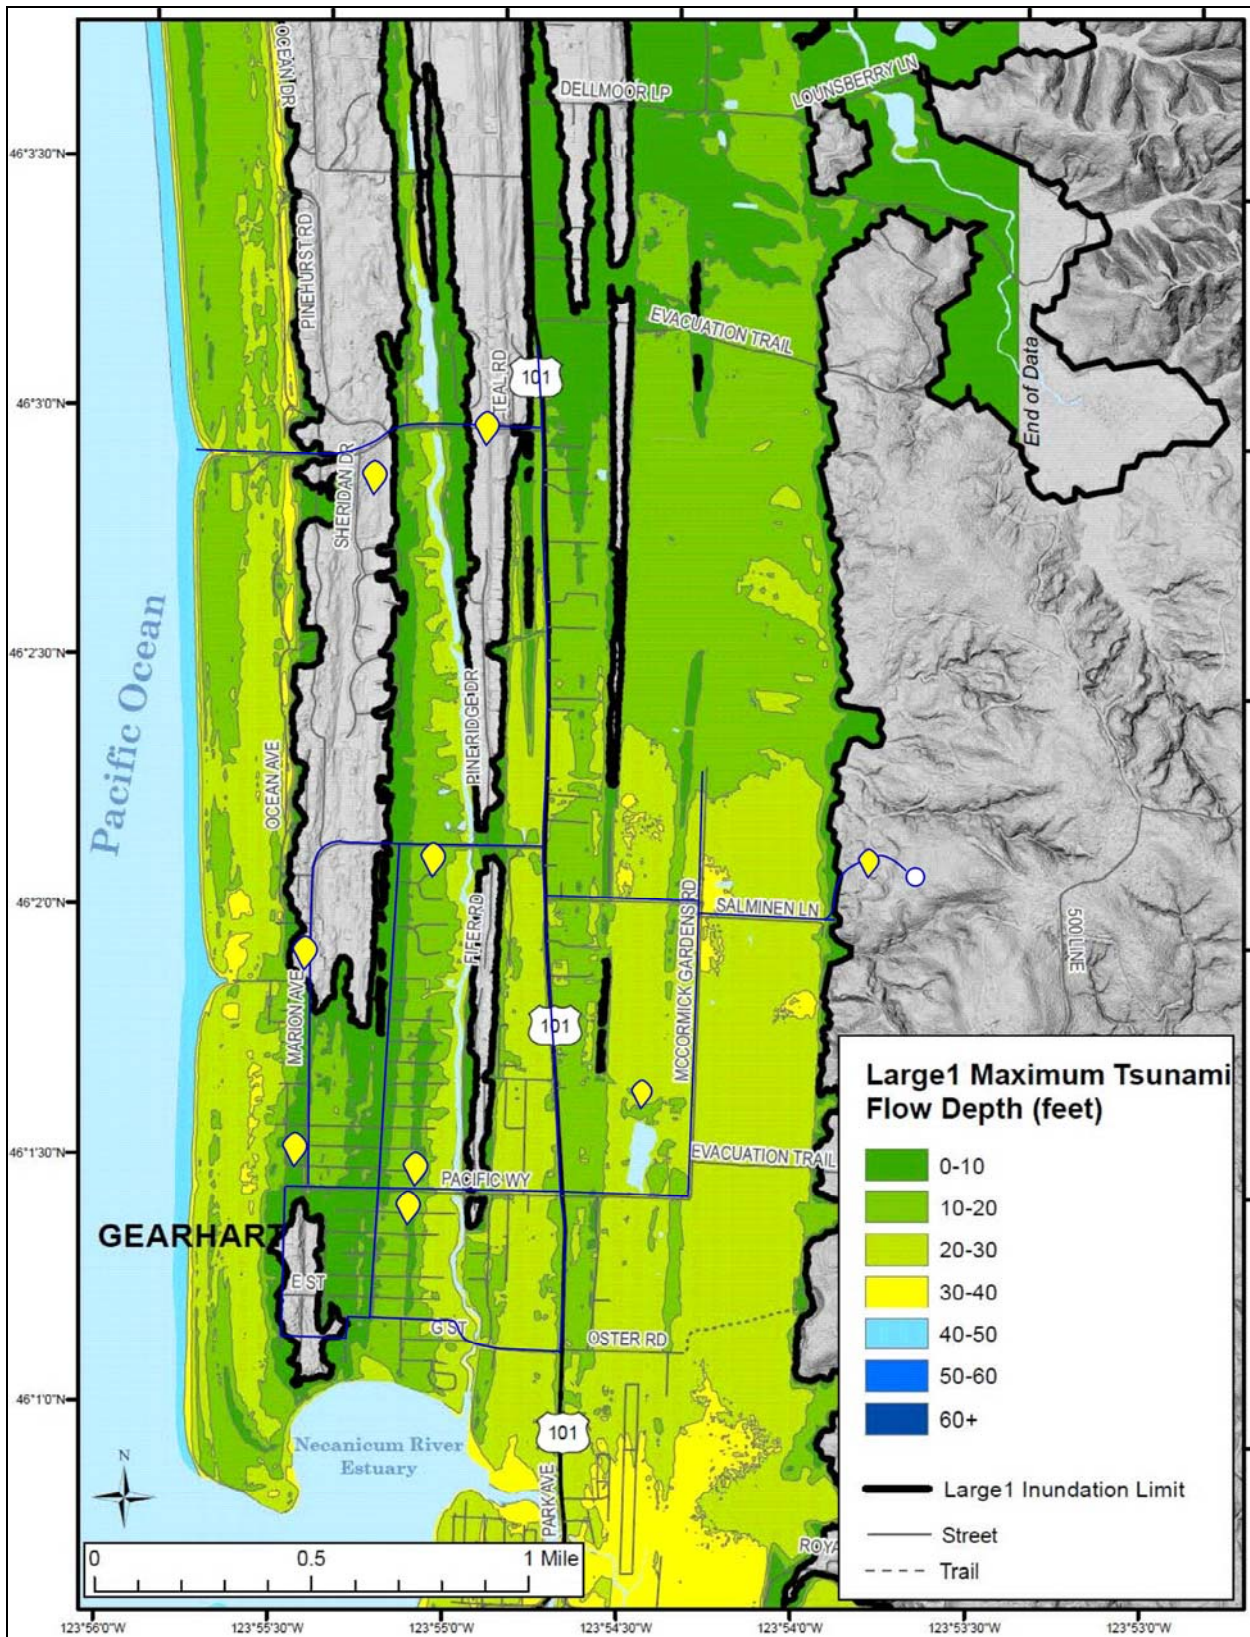
Figure 2: Maximum tsunami water flow depth map for the Gearhart area; water depth is color coded. This portrays run-up for a Large scenario wave, as shown in Figure 3. Uncolored areas are above tsunami run-up.

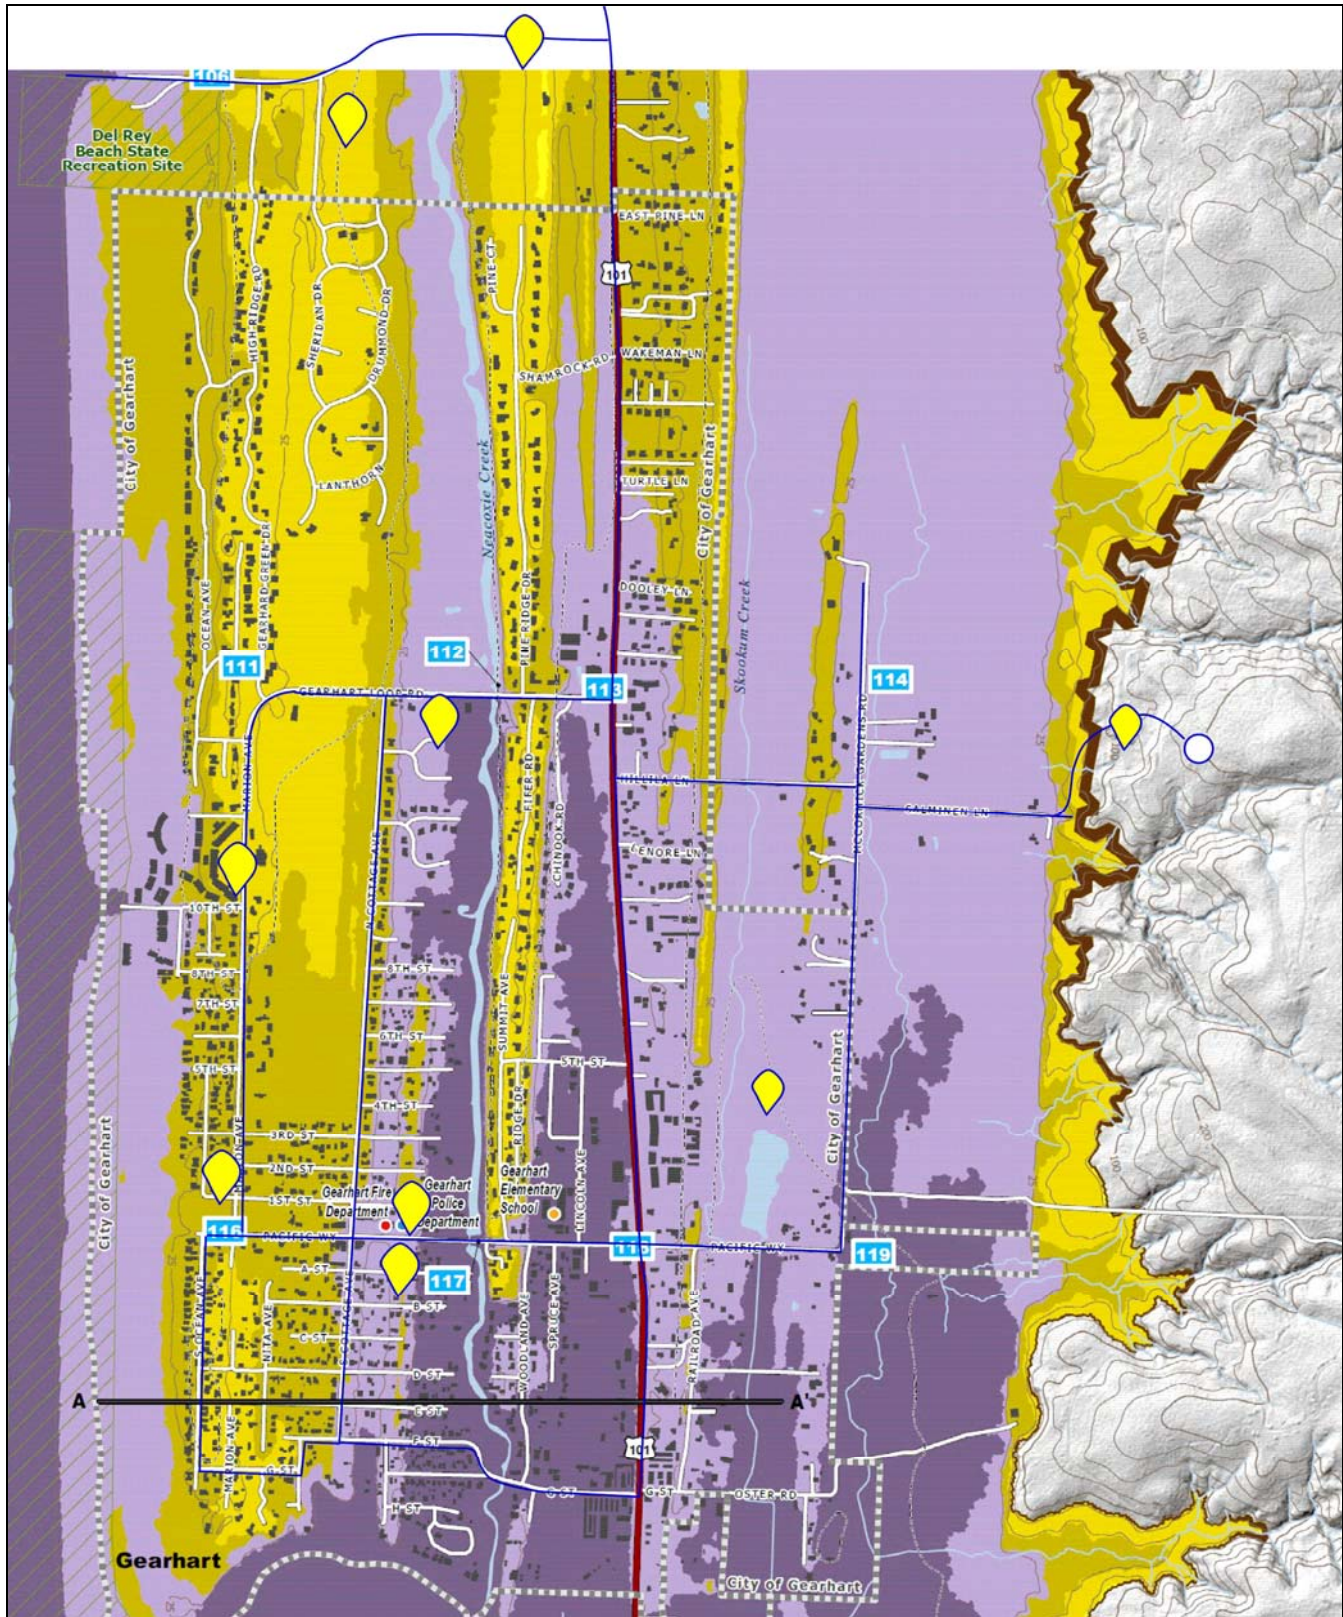
Figure 3: Tsunami inundation scenarios for Gearhart. Five wave height scenarios are color-coded: Small (dark purple), Medium (light purple), Large (dark mustard), Extra Large (yellow), and Extra-Extra Large (bright canary yellow). Extracted from the DOGAMI Gearhart TIM map.

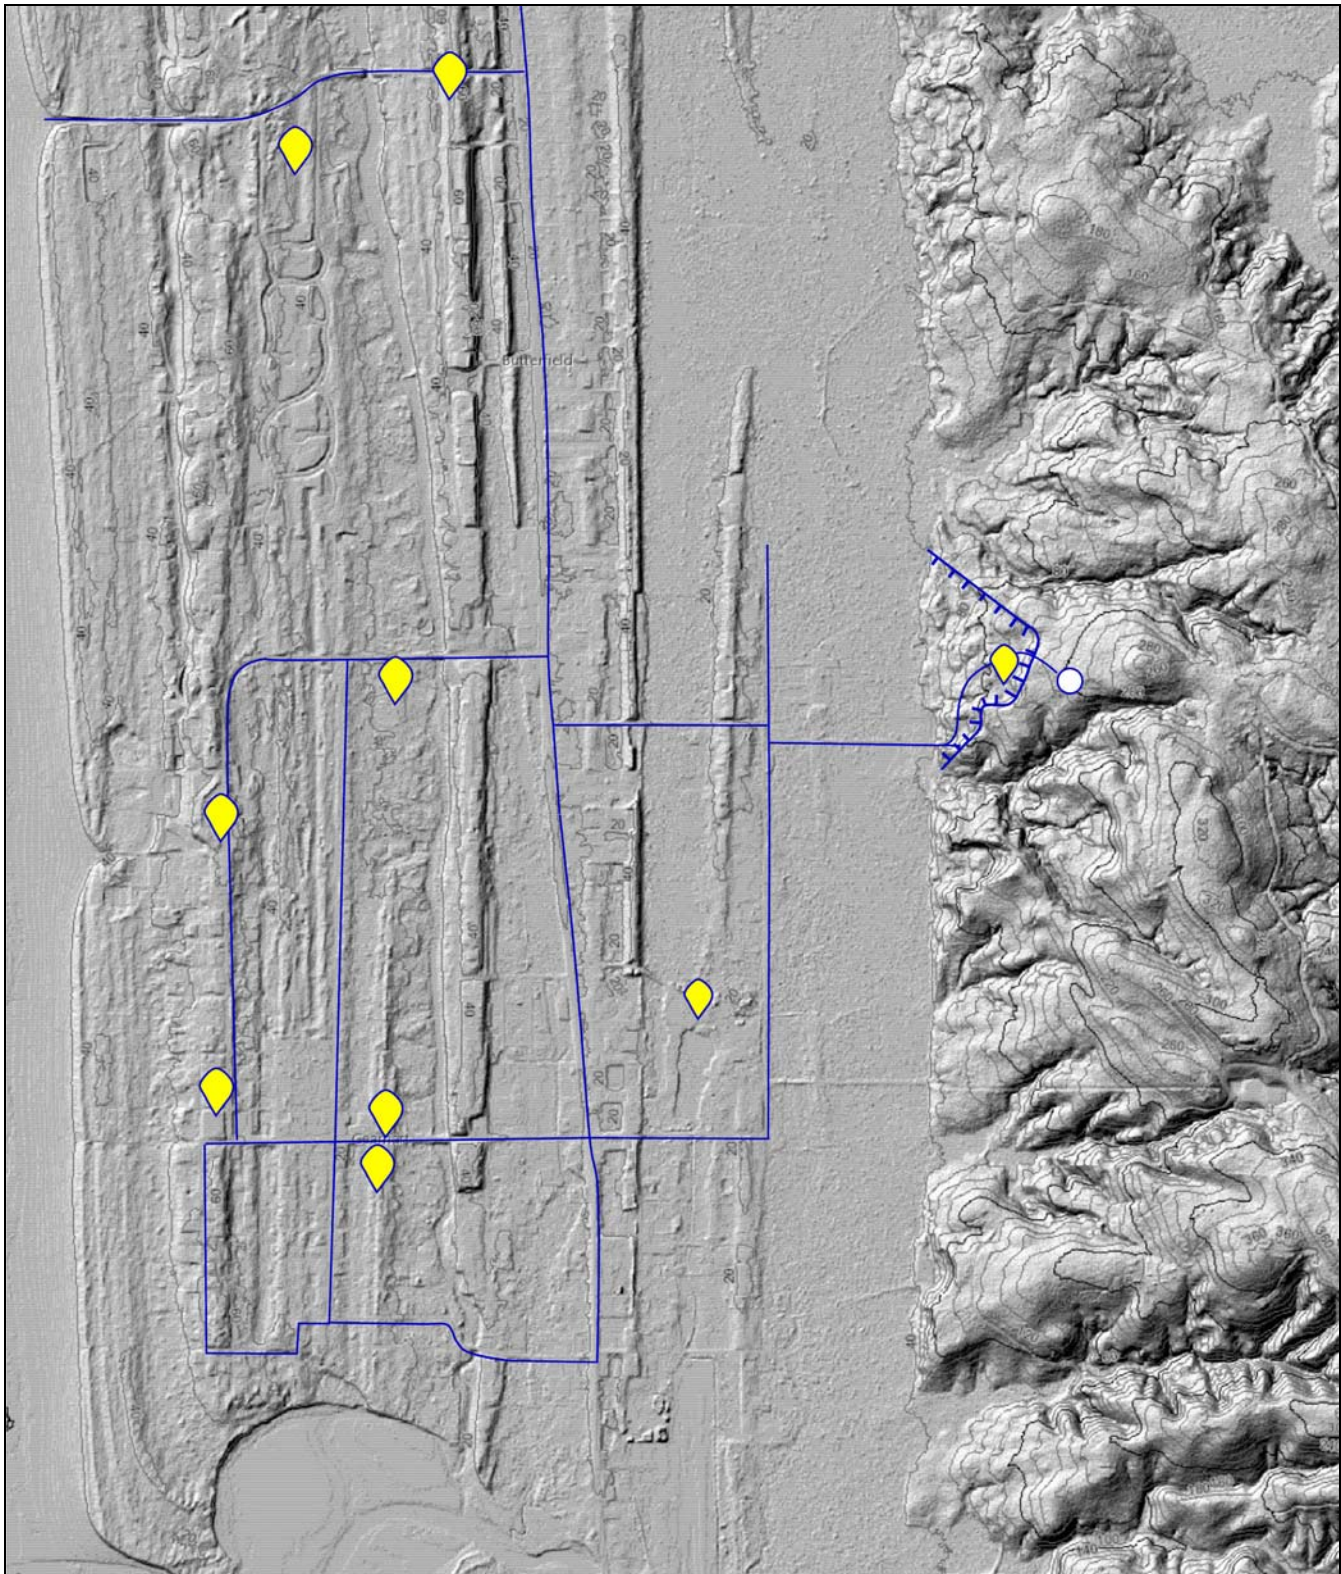
Figure 4: LIDAR map for the greater Gearhart area; blue hatched line denotes the boundary of a landslide at the east end of Salminen Road. The north side of the slide may be controlled by bedrock faults in mudstone, shown in Figure 5. The age of the slide is uncertain. It may have occurred in response to shoreline erosion 4500 years ago, or to seismic shaking during the ensuing period of time and 8 to 9 subduction zone earthquakes. Smooth hillslopes indicate areas free of landslide activity. Hills east of the south end of McCormick Garden Loop have limited landslide hazard. The swamp land will tend to flood and not drain after the earthquake.

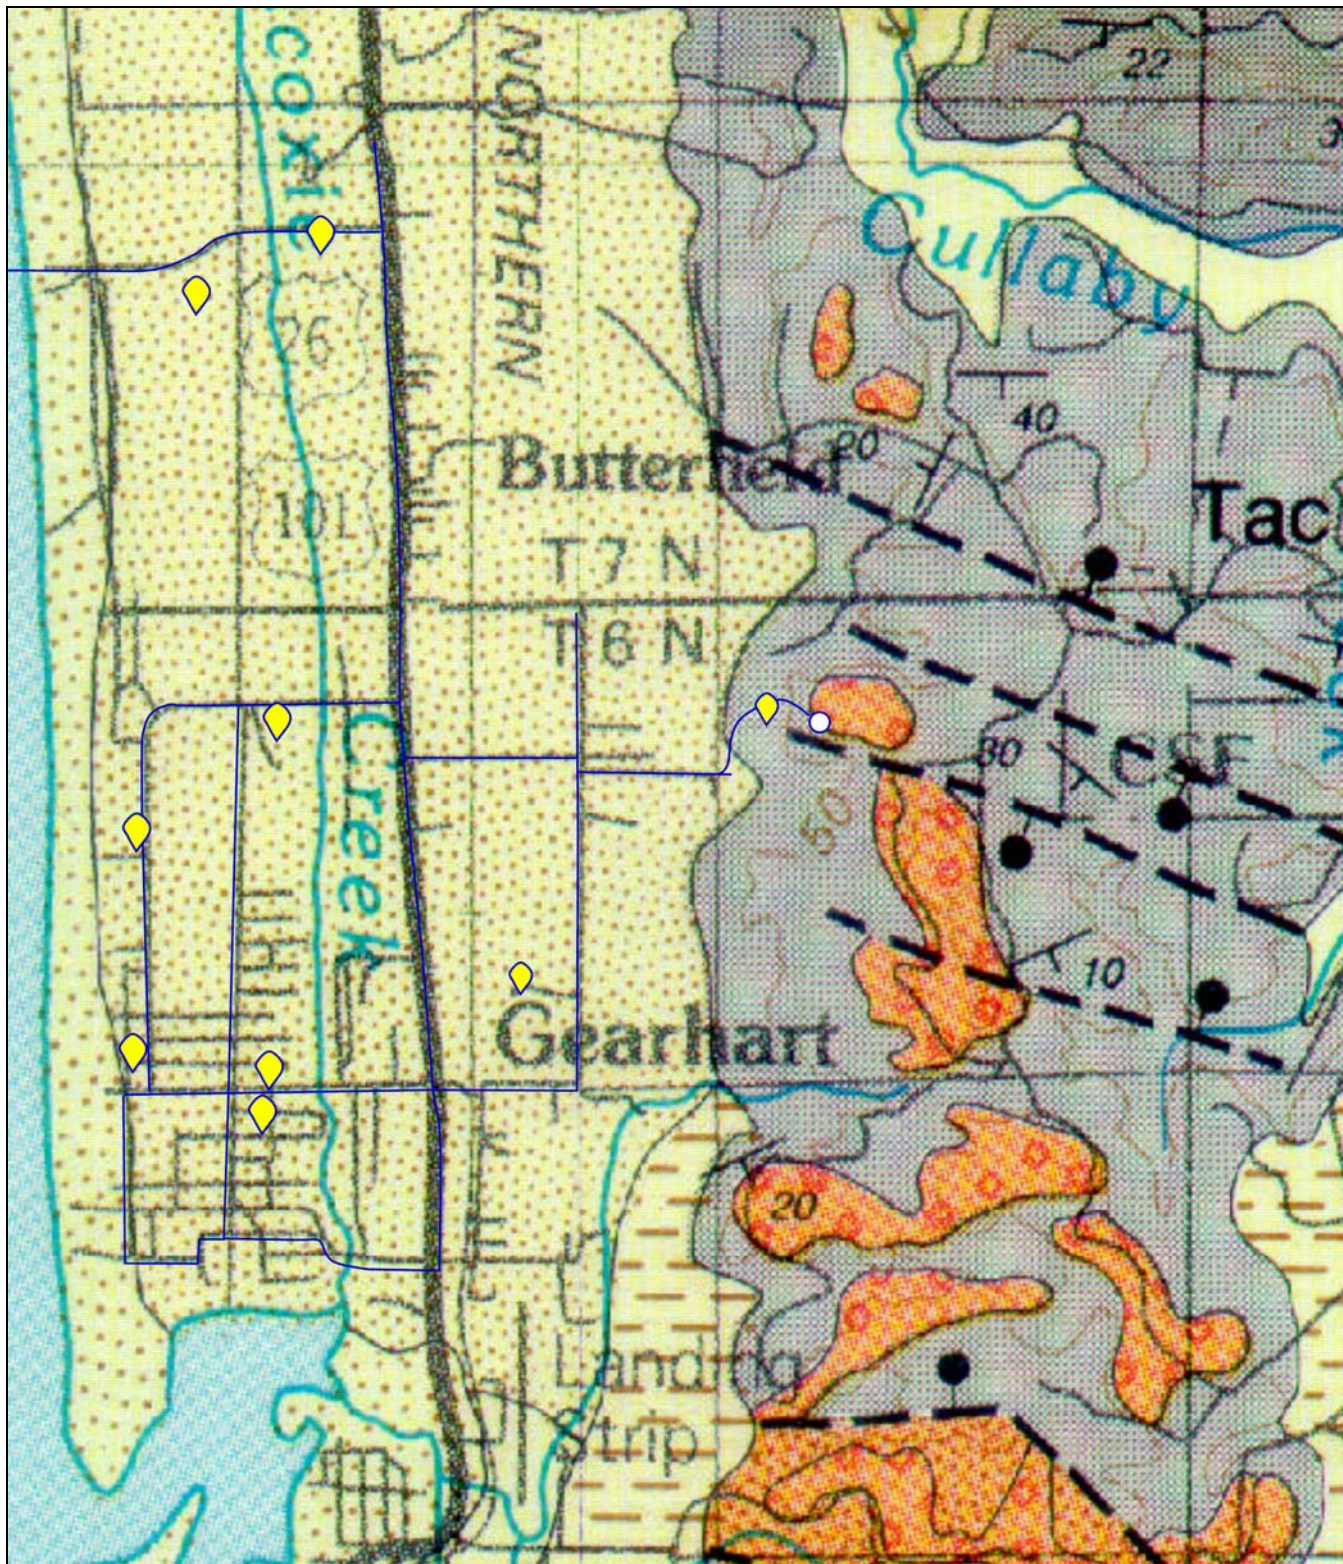
Figure 5: Geologic map for the Gearhart vicinity; after Niem and Niem (1985). Dune sand (straw-yellow stipple), laps against mudstone bedrock of the Cannon Beach member of the Miocene Astoria Formation (Tac), which is locally overlain or intruded by invasive pillow lavas of the 15-million-yr-old Frenchman Springs member of the Columbia River Basalt Group (orange, with circles). Minor deltaic sandstone (stippled orange) lies between the basalt and the mudstone in places. The water tank at Salminen Road lies on the edge of pillow lava bedrock, which will resist slope failure. The pipeline lying within weathered mudstone may be damaged by slope movements, based on interpreted landforms in Figure 4. Dark dashed lines are inferred faults; ball-on-stick denotes side of fault that has dropped.
