APPLICATION BEFORE THE CITY OF GEARHART PLANNING COMMISSION

Re: WD #2016-0255 Wetland Delineation Report for the Romine
Delineation, Clatsop County; T 6N R 10W S 3 TL 3300
City of Gearhart Local Wetland Inventory W-7

WETLAND DELINEATION / DETERMINATION REPORT COVER FORM

Figure 5
 SITE MAP
 Romine Delineation
 Ray Romine Construction LLC
 Clatsop County, OR
 Section 3, Township 6N, Range 10W, W.M.

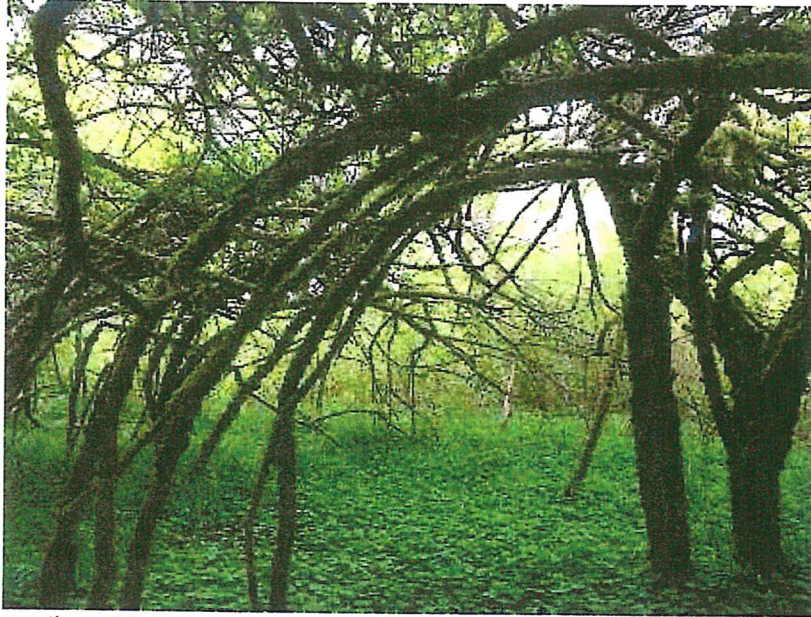
Above: 1. View southwest in the central portion of the site. This area is heavily shaded by mature spruce trees. The boundary of Wetland A is located just beyond the lily-of-the-valley across the central portion of the photo and is approximately 6 to 8 inches lower in elevation.

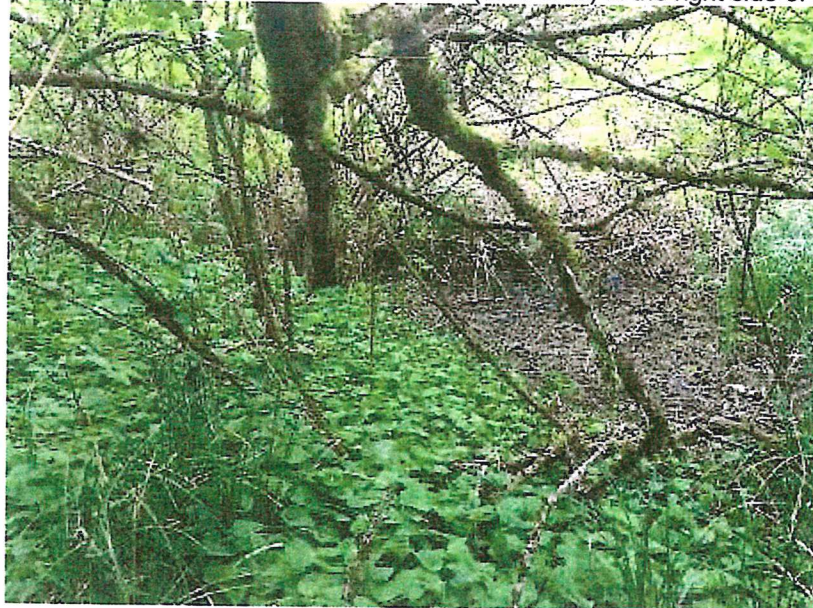
Below: 2. View looking southwest near the upland/wetland boundary. The ground slopes down approximately 6 to 8 inches to the wetland floor (bare area) in the right side of the picture.

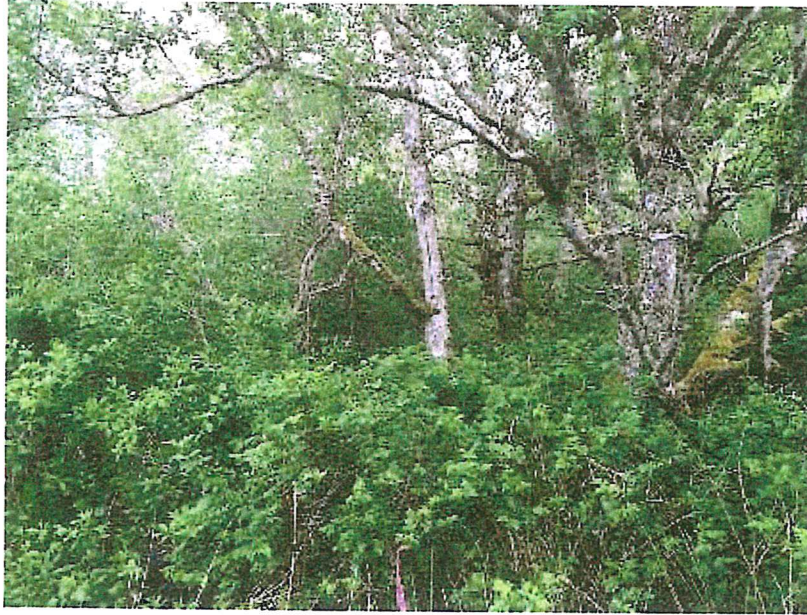
Above: 3. View of the southern boundary of Wetland A taken from Hillila Lane looking northwest.

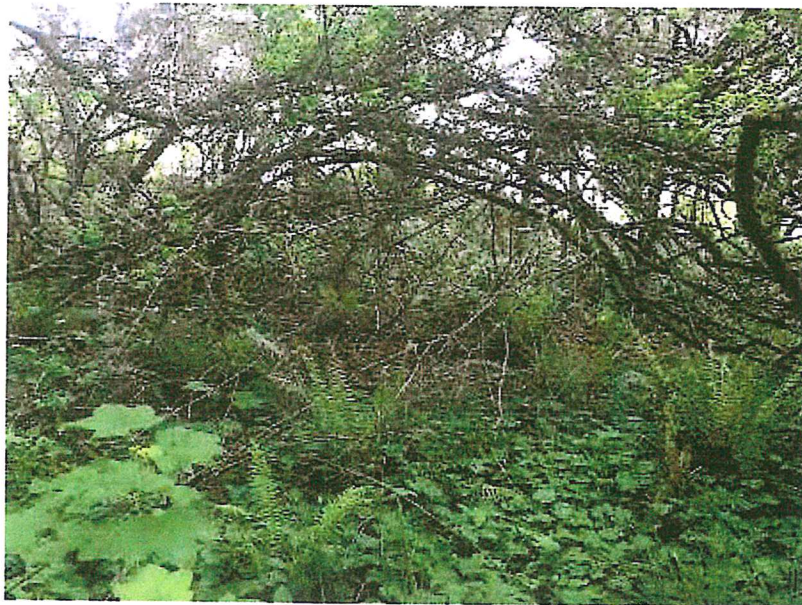
Below: 4. View southeast of the upland hillside in the southern portion of the study area.

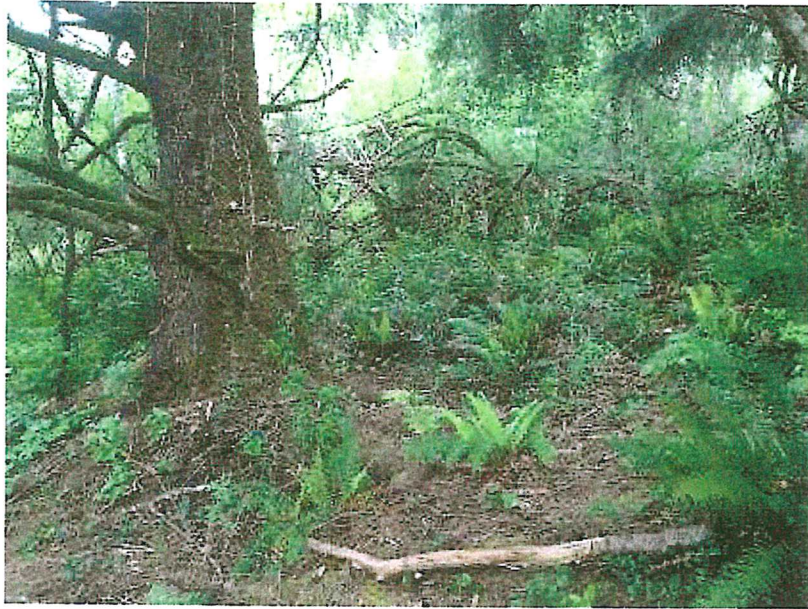
Below: 5. View of the overall representative condition of the forested hillside.
