Subject - New Business - Seismic Resiliency and Mitigation Plan Adoption

CITY OF GEARHART

Seismic Resiliency and Mitigation Plan

May 2022

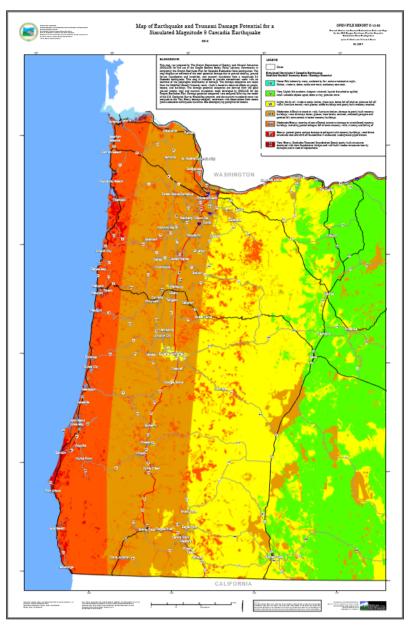
FIGURE 2-1: DOGAMI MAP OF DAMAGE POTENTIAL

The City has been identified as a Level VIII on the Oregon Department of Geology and Mineral Industries (DOGAMI) Oregon plate number 7 for earthquake and tsunami damage as shown on Figure 2-1. Due to the City's proximity to the coast, and in the event of a large (9.0+) Cascadia

Every community water system with more than 300 connections who submits a water system master plan is required to conduct "a seismic risk assessment and mitigation plan for water systems fully or partially located in areas identified as VII to X, inclusive, for moderate to very heavy damage potential using the Map of Earthquake and Tsunami Damage Potential for a Simulated Magnitude 9 Cascadia Earthquake, Open File Report 0-13-06, Plate 7 published by the State of Oregon, Department of Geology and Mineral Industries (see Figure 2.1).

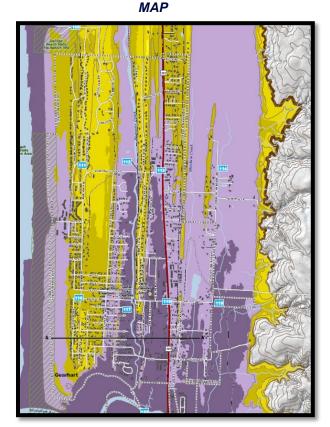
About 20 minutes after the initial shaking, a tsunami will, with high probability, hit the coast and inundate areas. In preparation for a Tsunami event, the City has established the Tsunami Hazard Overlay Zone for preparation of a Large "L" tsunami event as established by DOGAMI. Figure 2-2 shows a focused map of the City. A description of the color coding is shown in Figure 2-3 for the tsunami wave profile which is applicable on Figure 2-2. The larger referenced DOGAMI Map of Seaside-Gearhart can be seen in Attachment A of this report. The prepared inundation limit by the City has been FIGURE 2-2: DOGAMI TSUNAMI INNUNDATION

established at 49 feet above sea level. This will affect about 81 percent of the water service customers in the City. It will also affect City facilities within the inundation areas including the City Hall office on Pacific Way, the well field, and the Water Treatment Plant (WTP). (DOGAMI)
